Manhole Inspection Summary

Manhole # S51O__014MH

Insp Date: **10/6/08 1:29 PM**

Location Address: **s. linwood st.**

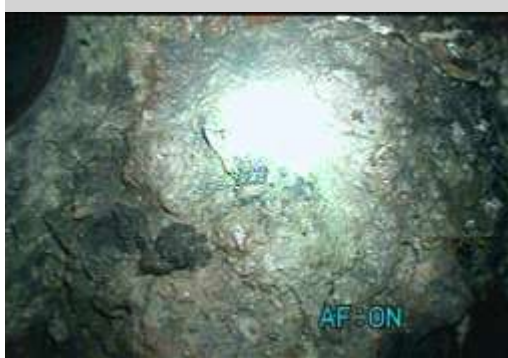
Defect 4

Condition: ☐ Sound ☐ Cracked ☐ Root Intrusion ☐ Deteriorated ☐ Leaks ☒ **Debris**

bench debris

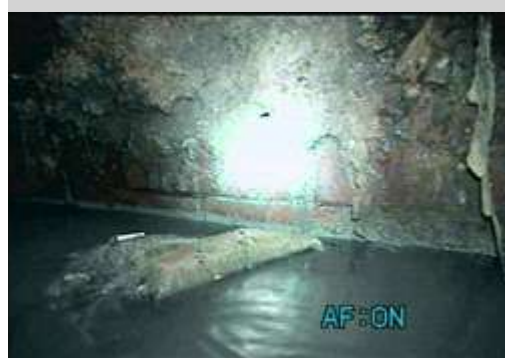
Defect 3

Condition: ☐ Sound ☐ Cracked ☐ Root Intrusion ☐ Deteriorated ☐ Leaks ☒ **Debris**

channel debris

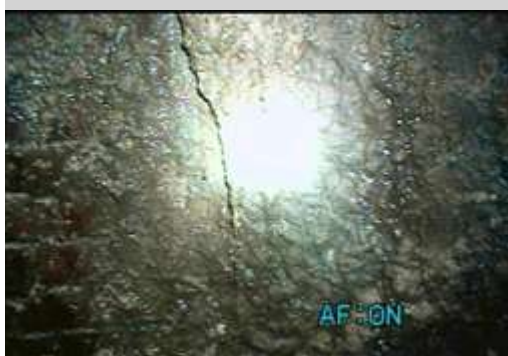
Defect 2

Condition: ☐ Sound ☒ **Cracked** ☐ Root Intrusion ☐ Loose Brick ☐ Deteriorated

Infiltration: ☐ None ☐ Joint ☐ Cracks ☐ Mortar ☐ Roots ☒ **Wall**

crack barrel, barrel infiltration

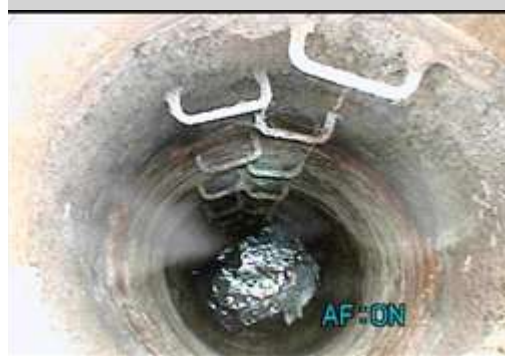
Defect 1

Condition: ☐ Sound ☐ Cracked ☐ Root Intrusion ☐ Loose Brick ☒ **Deteriorated**

Count: **14** Missing: **0** ☒ **Corroded**

corroded steps, deteriorated corbel

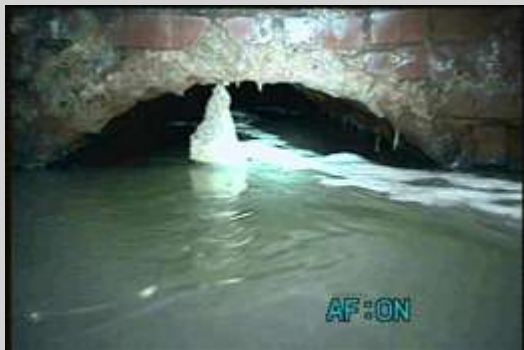
12 O'Clock Outflow

36 in. Circular Gravity Sewer
Pipe Out @ 12 O'Clock

Pipe Material: **Concrete** ☐ Pipe Lined

Invert Depth: **20.58** (ft.) Flow Characteristics: **Fast**

Infiltration: **None** Pipe Seal Cond: **Unknown**

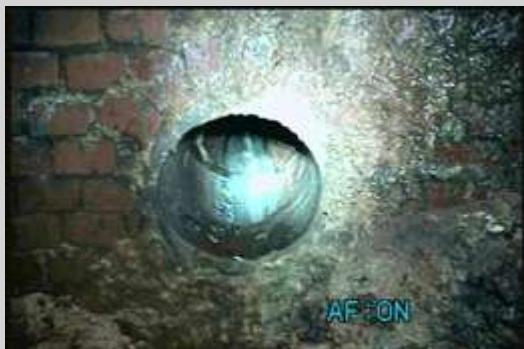
3 O'Clock Inflow

12 in. Circular Gravity Sewer
Pipe In @ 3 O'Clock

Pipe Material: **Clay** ☐ Pipe Lined

Invert Depth: **19.83** (ft.) Flow Characteristics: **Fast**

Infiltration: **None** Pipe Seal Cond: **Unknown**

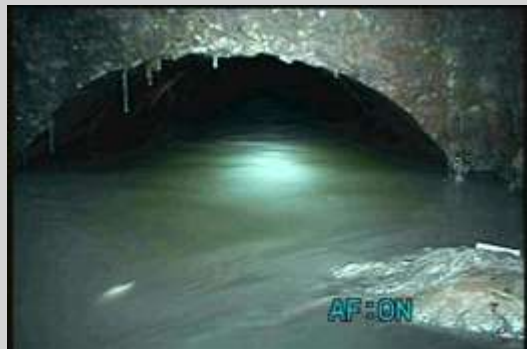
6 O'Clock Inflow

36 in. Circular Gravity Sewer
Pipe In @ 6 O'Clock

Pipe Material: **Concrete** ☐ Pipe Lined

Invert Depth: **20.10** (ft.) Flow Characteristics: **Fast**

Infiltration: **None** Pipe Seal Cond: **Unknown**
